# Inspection Report (PSI)

O-cn-1022355

<b>Client Name:</b>	Hebei Central Plumbing Industries		
	<b>Product Name:</b>	Ductile iron gate valve, Water Butterfly Check Valve, Centre Line Water Butterfly Valve		
	<b>Inspection location:</b>	Hebei		
	<b>Your reference number:</b>			
	<b>P/O number:</b>			
	<b>Supplier:</b>	Hebei Central Plumbing Industries		
	<b>Order quantity:</b>	787		
	<b>Pcs ready for inspection:</b>	787 (100%)		
	<b>Reference sample available:</b>	n/a

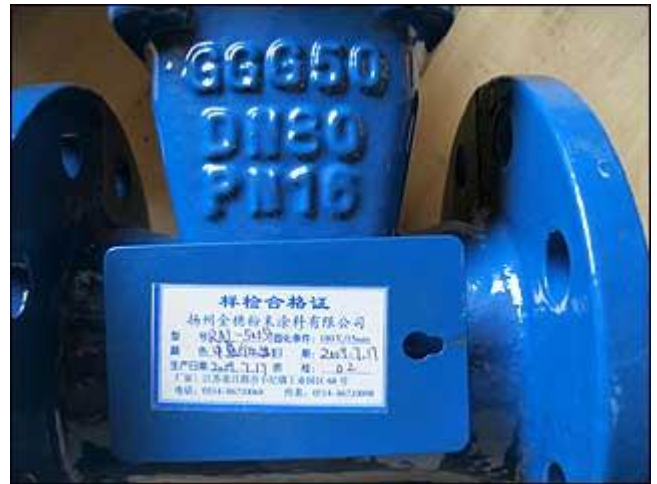
Expected Result	Result	Pantone code	Comments
--	n/a	n/a	The color compare with RAL PANTONE ,found a slightly difference ,Please see below picture
Client's comments:

Blue DN80 compared with RAW PANTONE

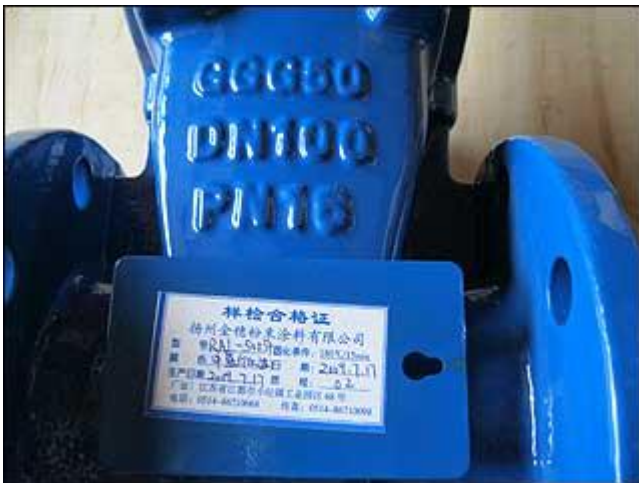
Blue DN100 compared with RAW PANTONE

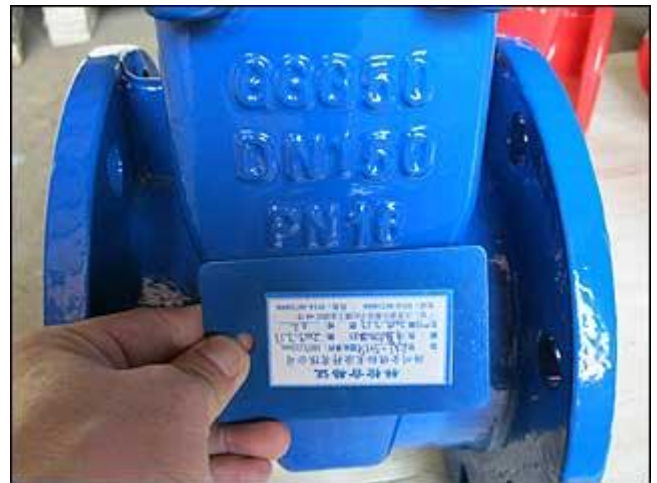
Blue DN150 compared with RAW PANTONE

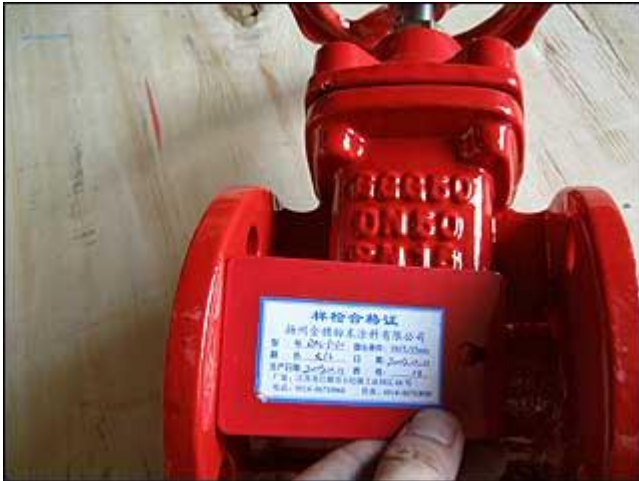
Red DN50 compared with RAW PANTONE

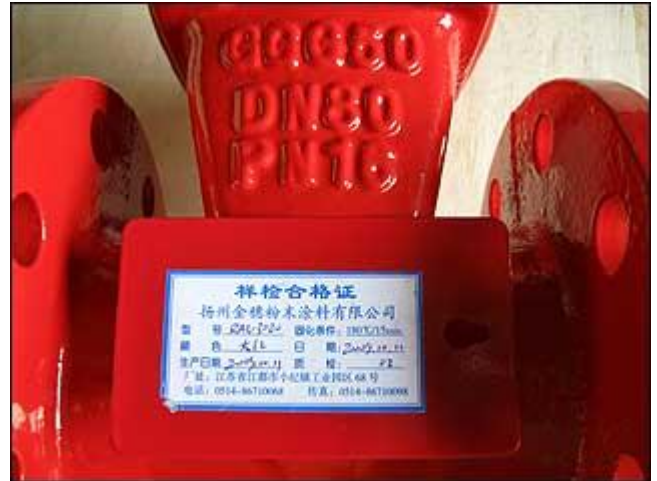
Red DN80 compared with RAW PANTONE

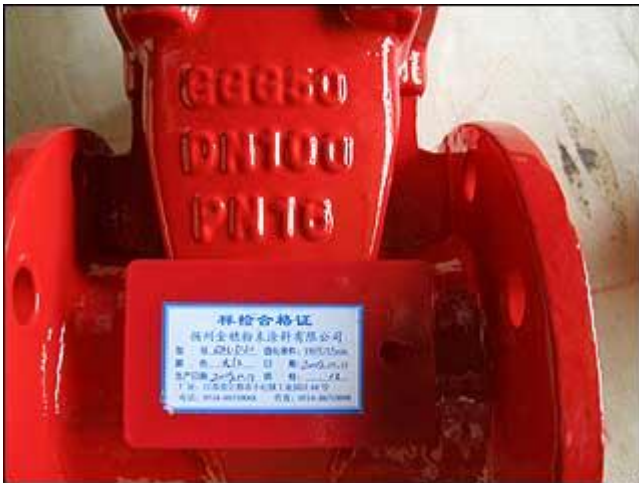
Red DN100 compared with RAW PANTONE

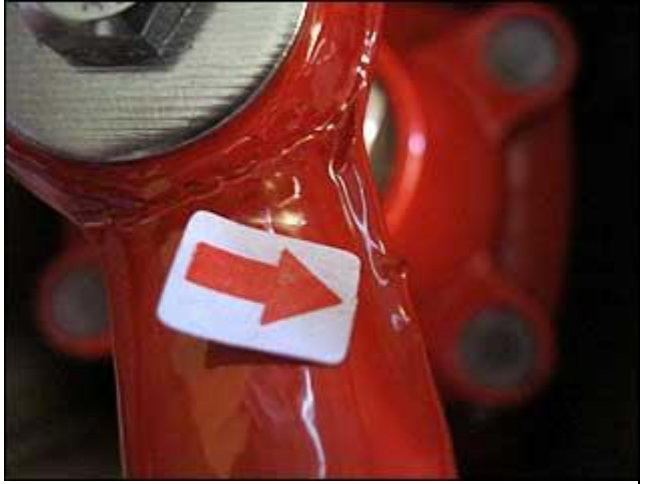
DEFECTIVES LIST					
		CRI	MAJ	MIN	Picture
1	<ul style="list-style-type: none"> <li>- Sharp point</li> <li>- For item red DN50</li> </ul>	1	0	0

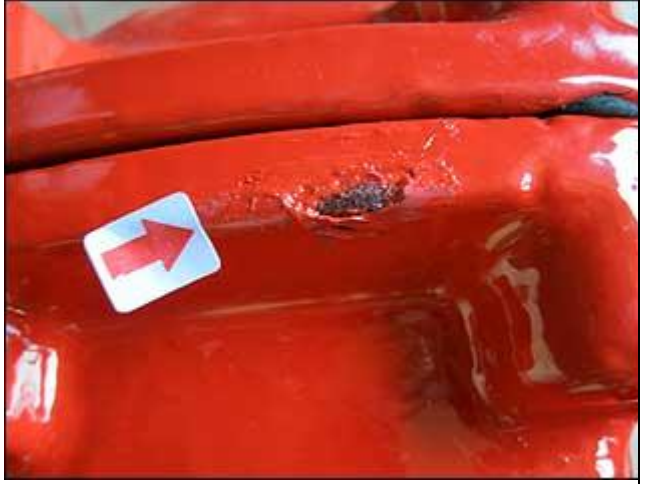
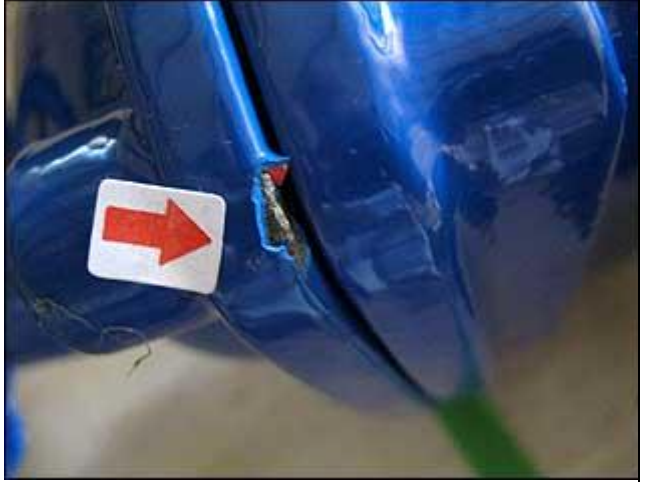
2	<ul style="list-style-type: none"> <li>- Peel off</li> <li>- For red DN100 1 pcs</li> <li>- For blue DN80 1 pcs</li> </ul>	0	0	2

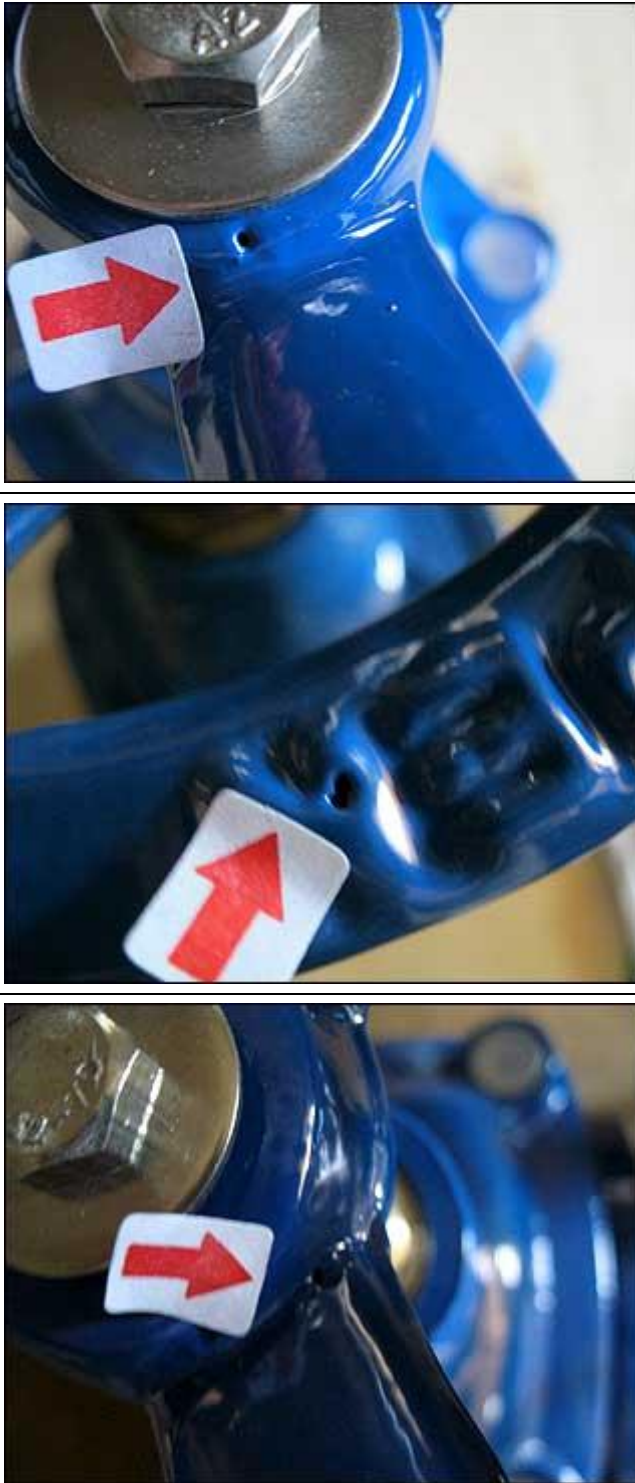
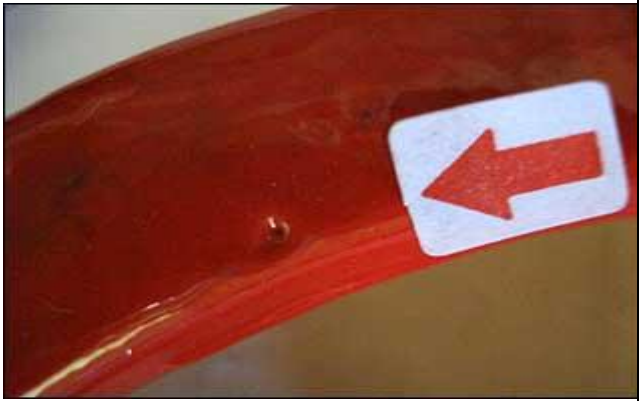
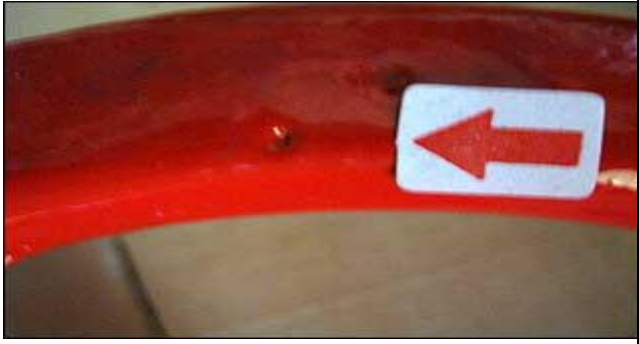
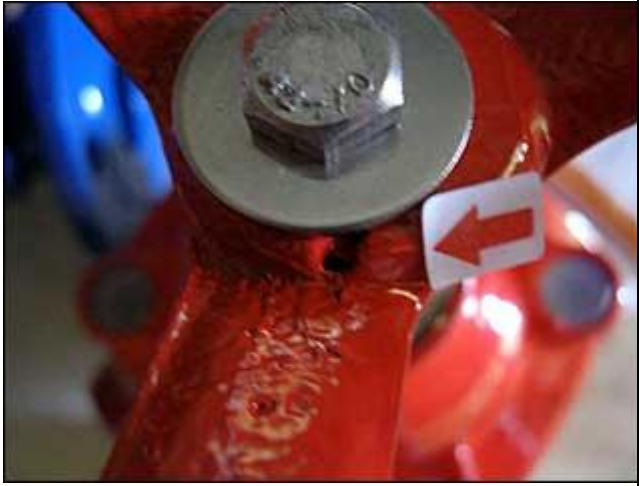
3	<ul style="list-style-type: none"> <li>- Hole on surface</li> <li>- Red DN100 1 PC</li> <li>- Red DN50 2pcs</li> <li>- Blue DN50 1pc</li> <li>- Blue DN80 1 pcs</li> <li>- Blue dn150 1pc</li> </ul>	0	6	0
