# Inspection Report (PSI)

O-cn-1022355

<b>Client Name:</b>	Hebei Central Plumbing Industries		
	<b>Product Name:</b>	Ductile iron gate valve, Water Butterfly Check Valve, Centre Line Water Butterfly Valve		
	<b>Inspection location:</b>	Hebei		
	<b>Your reference number:</b>			
	<b>P/O number:</b>			
	<b>Supplier:</b>	Hebei Central Plumbing Industries		
	<b>Order quantity:</b>	787		
	<b>Pcs ready for inspection:</b>	787 (100%)		
	<b>Reference sample available:</b>	n/a

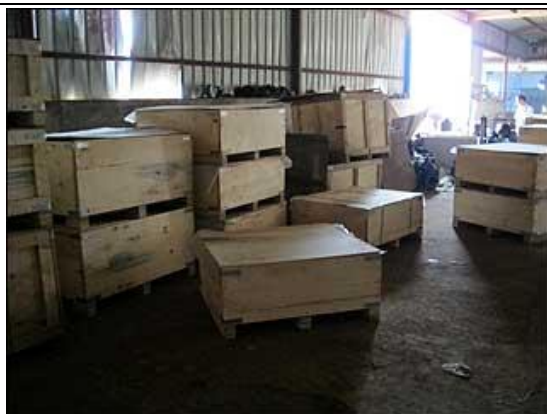
Finished and packed

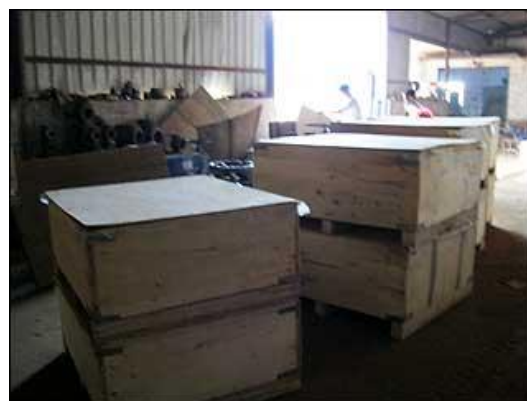
Finished and packed

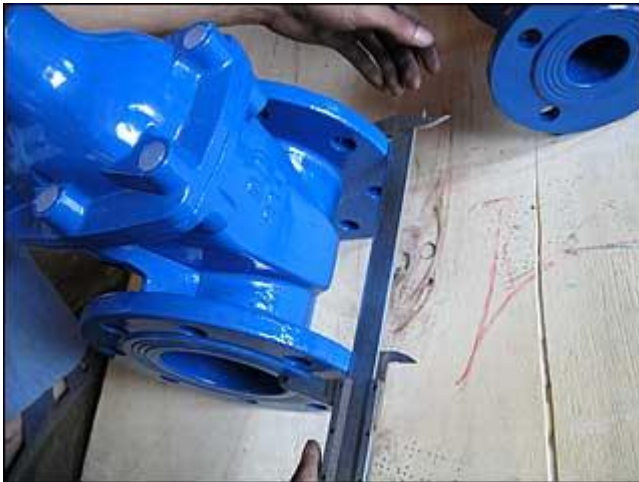
Expected Result	Result	Actual Finding / Comments
	Not OK	Please refer to below test measure table

Dimension L check

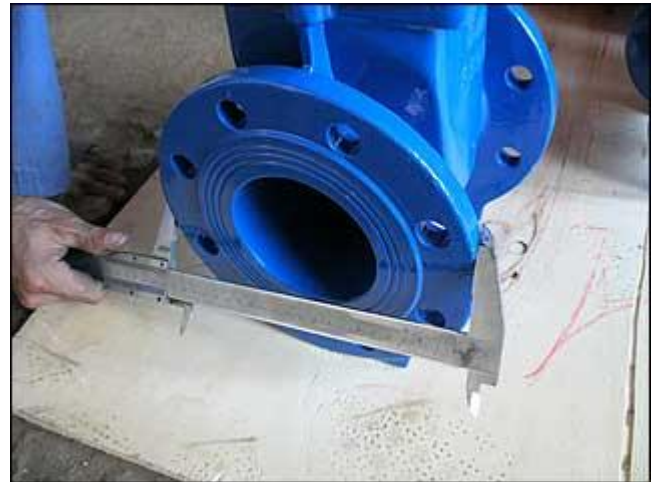
Dimension D check

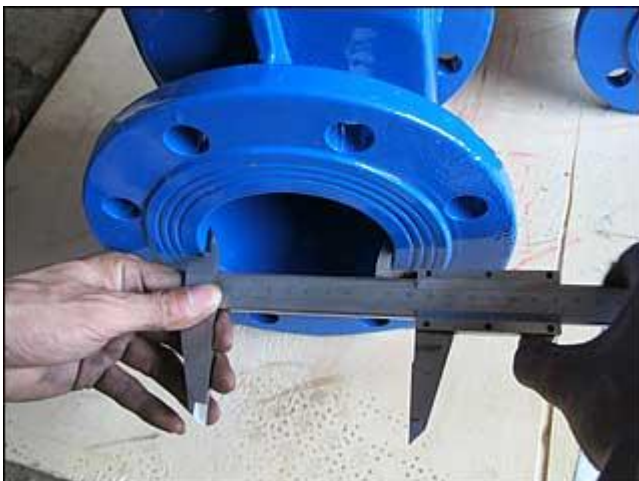
Dimension DN check

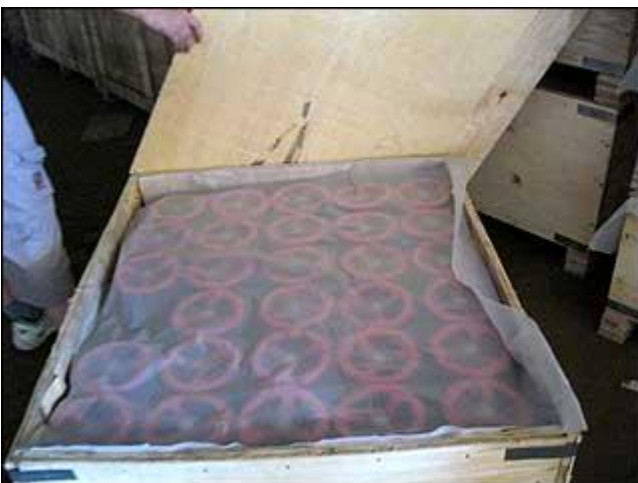
PE cover

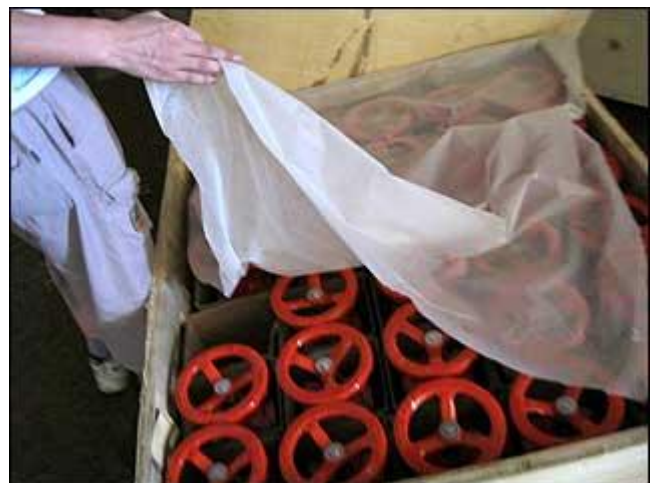
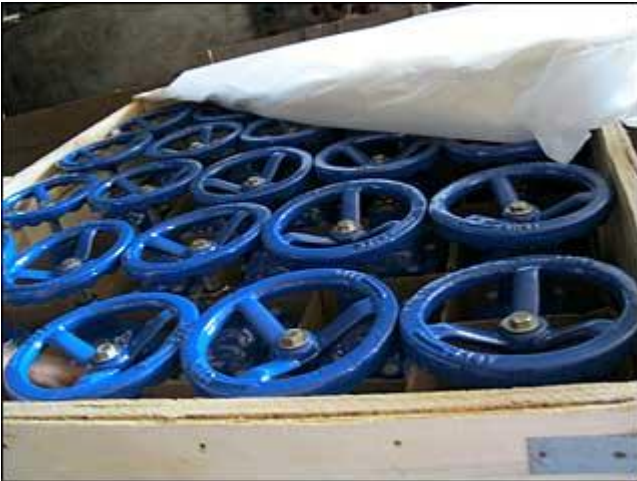
The rows was divided by cardboard

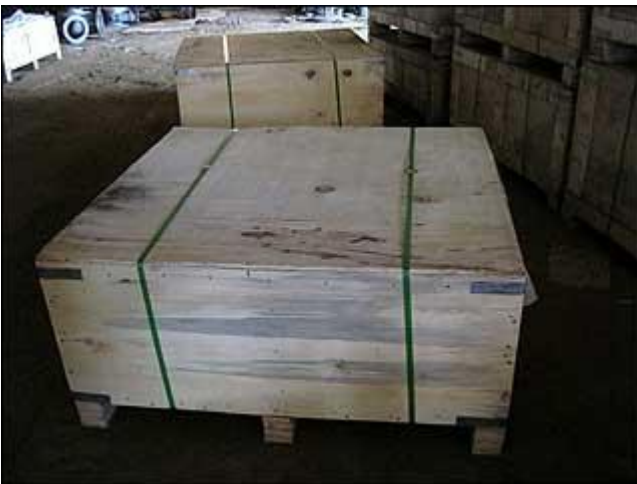
Wooden box Sealed with nails and plastic band

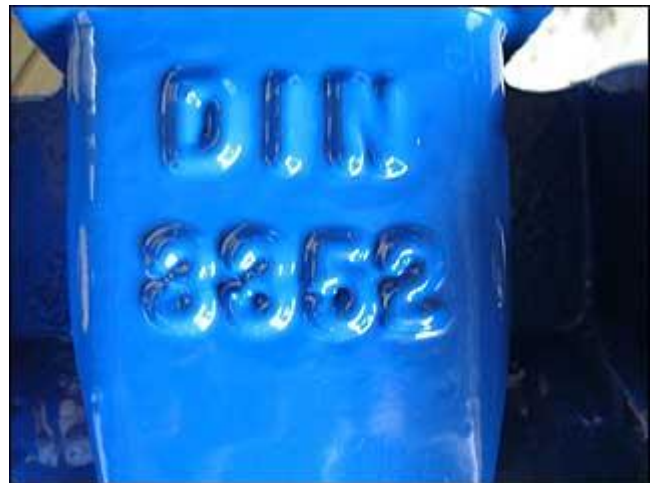
Mark on surface

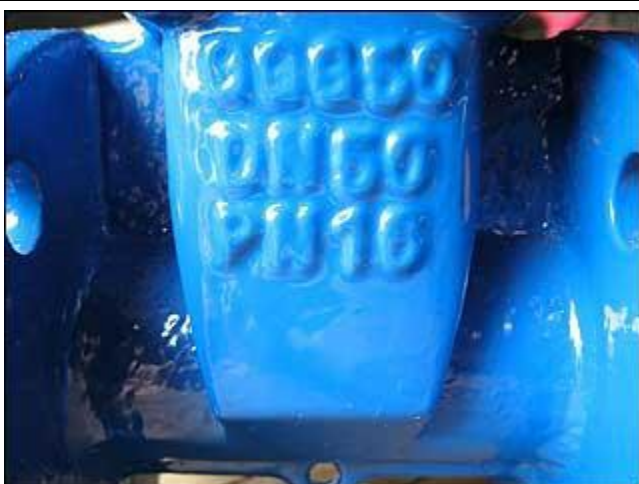
Mark on surface

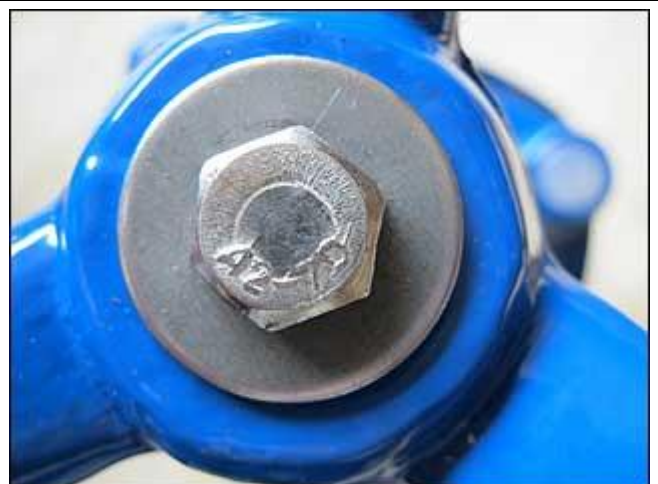
Mark on screw
